Lunar Dust Protection for Apollo Rover Mechanisms

Ron Creel - Lead for LSIC Dust Mitigation "Isolation Technologies" Subgroup

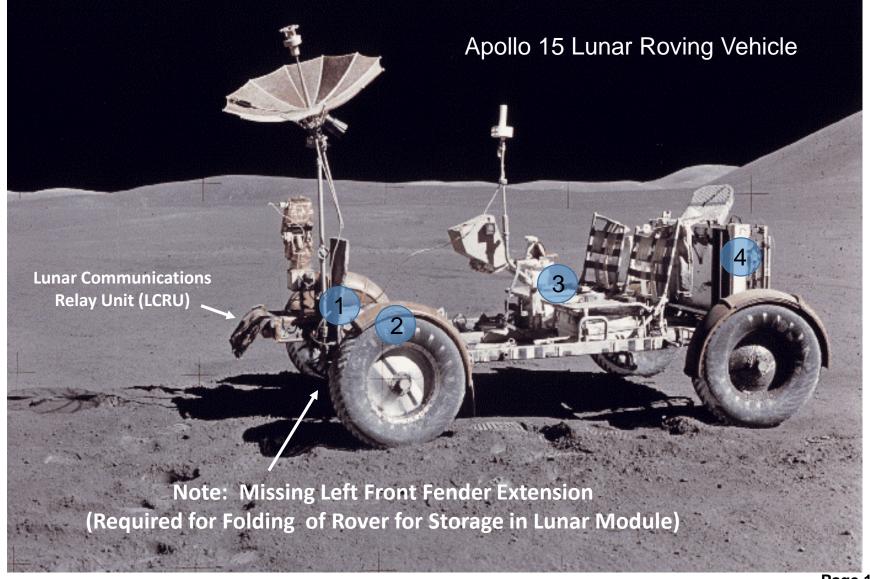
Kevlar Shield to Protect Rover from LM Lander Stirred Up Dust

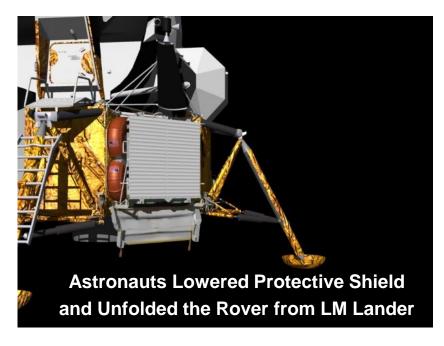
Lunar Dust Brush

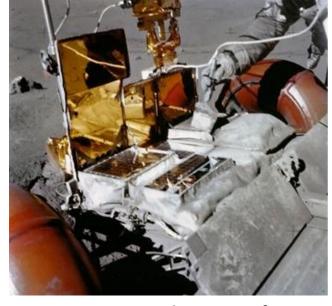
Astronaut Brushing Dust from LRV Thermal Radiators

Misleading Pre-Apollo 15 <u>Earth TVAC Testing</u> at the Manned Spacecraft Center, Using Apollo 12 Soil and Much Higher Pressure (10⁻⁶ Torr), Predicted Brushing Could Be Used on the Moon to Effectively Clean Thermal Control Surfaces and Crew Suits

Extensive Dust Cleaning Regrettably Did NOT Work on the Moon with Much Lower Environmental Pressure of 10⁻¹² Torr

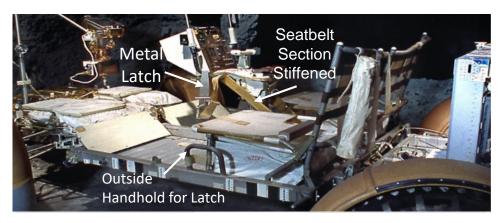
KC-135 Testing Required for "1/6 G" Seatbelt Redesign

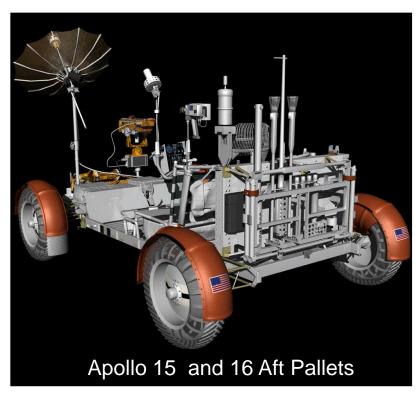
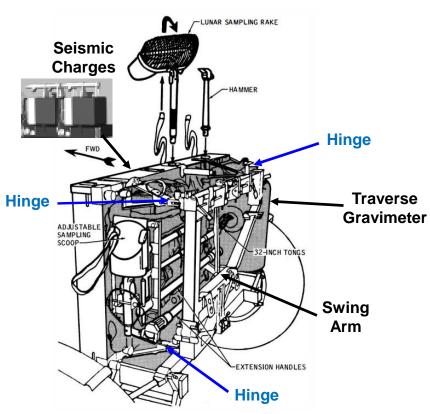
Geological Tools on Apollo 17
Aft Pallet

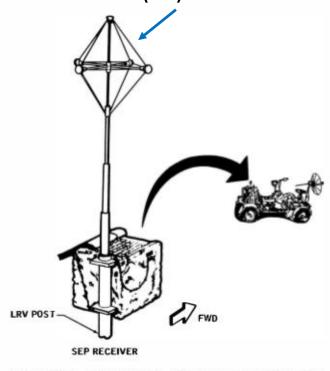
SEP receiver. The receiver is mounted on the rear of the Rover. Data, measured while the Rover moves along a traverse, are also recorded automatically on a cassette tape recorder.

SEP Receiver Mounted on Apollo 17 Aft Pallet Front Side
